# Army Lodging Wellness Recommendation

## Fort Hood - Final Submittal

August 4, 2003

# Section 1 Wellness Recommendation

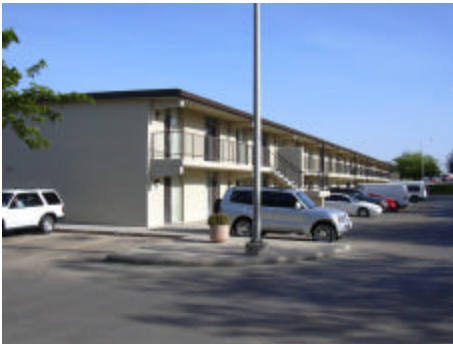
### ***Lodging Building 111***

Building 111, Poxon House, constructed in 1972, is located near the main gate along Fort Hood Road, in close proximity to Keith Ware Hall. This facility houses 75 standard rooms, approximately 305 square feet each, and meets Army Lodging size requirements. It is recommended that Poxon House continue to serve as part of Fort Hood's lodging inventory.

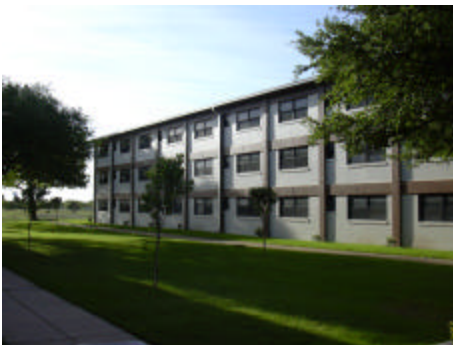
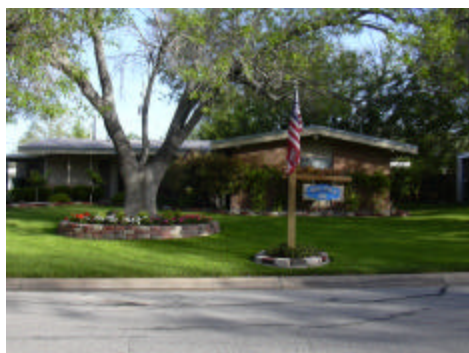
### ***Lodging Buildings 5786, 5788, 5790, & 5792***

The 5700 series lodging buildings were built in the late 1950's and consists of 111 family suites and 7 standard rooms. At approximately 520 square feet per suite, these rooms are somewhat larger than current Army Lodging standards. Many of these buildings' systems are nearing the end of their useful lives and are in poor condition as noted in the Facility Assessment. The cost to make condition assessment improvements will exceed the 50% replacement cost.

Our recommendation is to remove these buildings from the Lodging inventory, allowing the installation to determine an alternate use for the facilities. These facilities will be removed from the Fort Hood Wellness Solution and Lodging master plan.

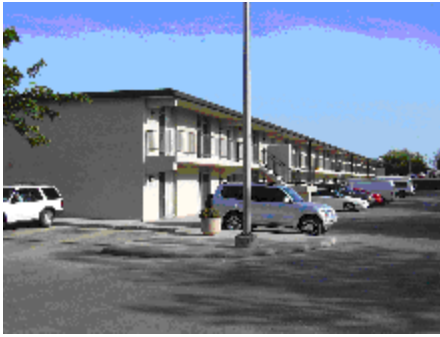
*Building 111  
Poxon Guest House*

Condition Assessment Cost	\$1,503,685.00
Replacement Cost	\$5,485,330.00
Condition Assessment to Replacement Cost Ratio	27.41%

Because the Condition Assessment to Replacement Cost Ratio is less than 50%, repair and continued use of Building 111 is recommended.

- Analysis: The wall finishes are a combination of paint over CMU or drywall. The paint is in poor condition.
- Recommendation: Prep and prime the wall surfaces for a new two coat paint system.

- Analysis: Carpet is located in all guest rooms and in some common areas. The guest bathrooms have tile floors. VCT is used in the common kitchen and other areas. The carpet and VCT are in fair condition. The tile is in good condition.
- Recommendation: Replace the carpet and VCT.

- Analysis: A suspended acoustical ceiling and grid is used in all common areas and is in fair condition. The guest rooms have painted drywall ceilings in fair condition.
- Recommendation: Replace the suspended acoustical ceiling and grid and repaint the guest room ceilings.

- Analysis: The building is conditioned by a chilled water circulating system with central controls.
- Recommendation: Install package terminal units with heat and individual controls in each room.

- Analysis: The building does not have a sprinkler system.
- Recommendation: Install a sprinkler system.
